# Rail Transportation Safety Investigation Report R18T0032

## **CROSSING ACCIDENT**

VIA Rail Canada Inc.  
Passenger train No. 85  
Mile 57, Guelph Subdivision  
Breslau, Ontario  
08 February 2018

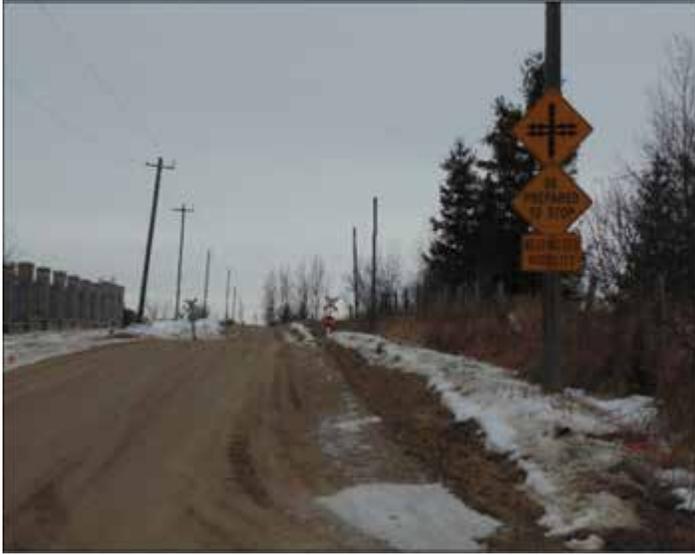
Advance warning signs are present along the road about 100 m in advance of the crossing in both directions. The advance warning signs inform vehicle drivers that visibility is restricted and to be prepared to stop at the crossing (Figure 2 and Figure 3).

Figure 2. Advance warning sign 100 m from the crossing (south of the track, travelling north)

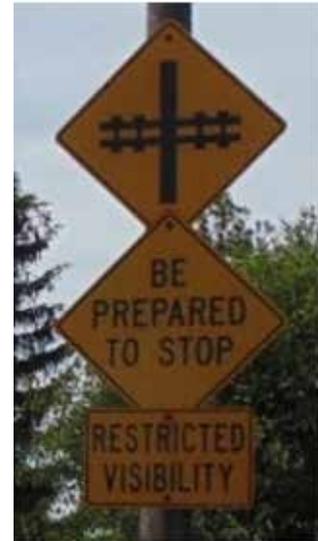
Figure 3. Close-up view of advance warning sign

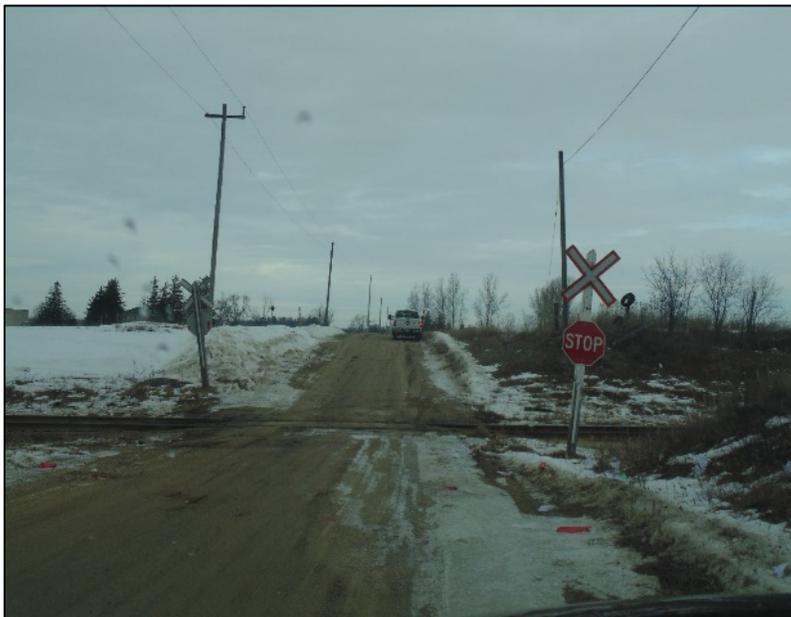
The crossing is equipped with SRCS with stop signs secured to the posts, located about 6 m from the nearest rail on each side of the track (Figure 4).

Figure 4. Standard railway crossing sign with stop sign at the crossing (south of the track, looking north)

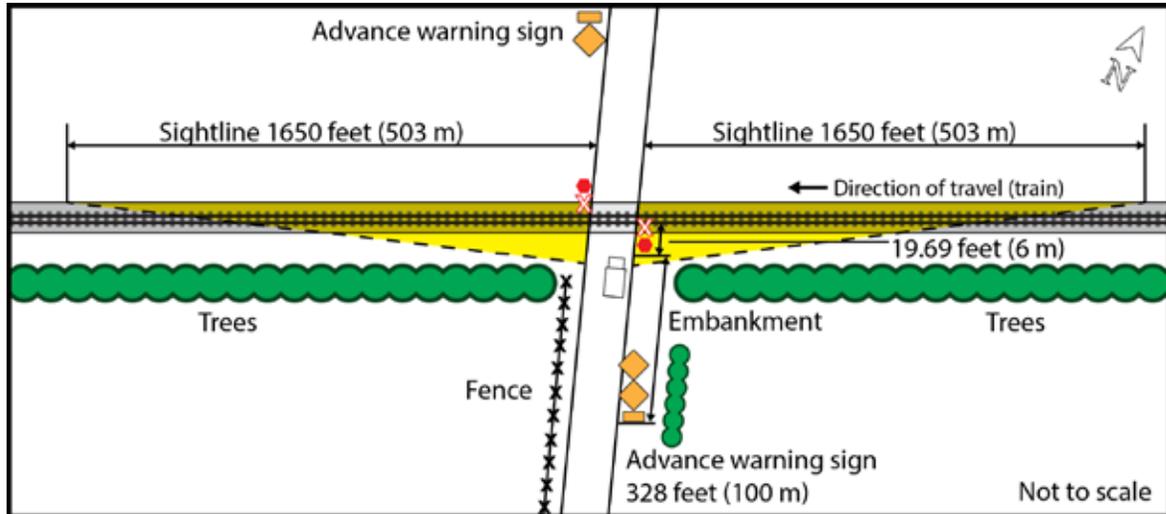
At the Wurster Place crossing, vehicles stopped on the south approach to the crossing looking north had sightlines of at least 1650 feet (503 m) to the east and to the west (Figure 5). These sightlines met regulatory requirements.

Figure 5. Passive protection and sightlines at the Wurster Place crossing

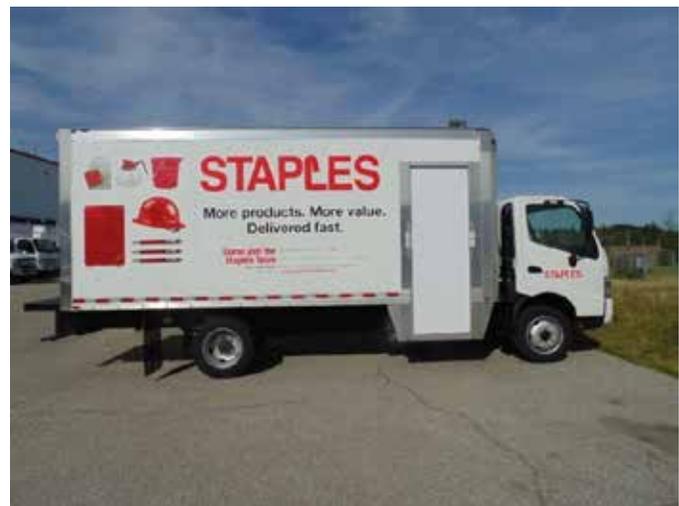
The truck was a 2018 cab-over design, manufactured by Hino (Figure 6). It had an odometer reading of about 5000 km and was in new condition. It weighed 14 900 pounds with a lading capacity of 4900 pounds. The forward and peripheral sightlines from within the truck cab were good.

Figure 6. A Staples delivery truck similar to the occurrence vehicle
